ROAD SAFETY AUDIT

East Main Street (Route 16) at Medway Road (Route 109),
East Main Street (Route 16) at Quarry Square Driveways,
East Main Street (Route 16) at Beaver Street/
Fortune Boulevard

Town of Milford

May 18, 2017

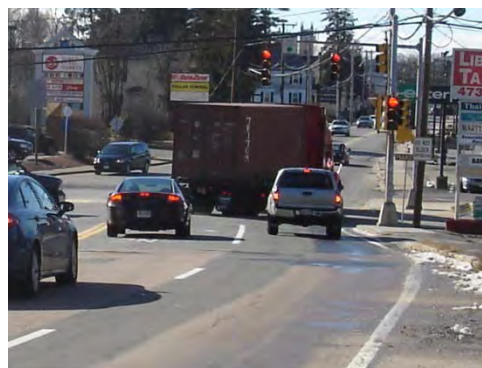
To the east of the intersection, East Main Street (Route 16) consists of two travel lanes in each direction. On the approach to the intersection, the left westbound lane becomes an exclusive left-turn lane, approximately 75 feet in advance of the stop line, as shown in **Figure 2** and **Image 1**. This lane-drop configuration is often called a left-turn lane trap. The transition from a general-purpose travel lane to an exclusive turn lane at this location is abrupt with no advanced warning. This configuration creates a situation where vehicles attempt to make last-moment lane changes, particularly from the left lane to the right lane in order to continue going straight. As observed in the field, vehicles sometimes make a through movement from the left lane, probably having not noticed the change in lane configuration in time to merge before the intersection, which results in a merge situation within or just beyond the intersection that is unexpected for drivers in the other lane. Two sideswipe crashes identified in the crash history analysis are likely attributed to this issue, where a vehicle in the left lane attempted a sudden lane change to the right on the approach to or within the intersection, striking a vehicle to its right.

Image 1: Westbound Approach to Medway Road (Route 109) Intersection with Left-Turn Lane Trap

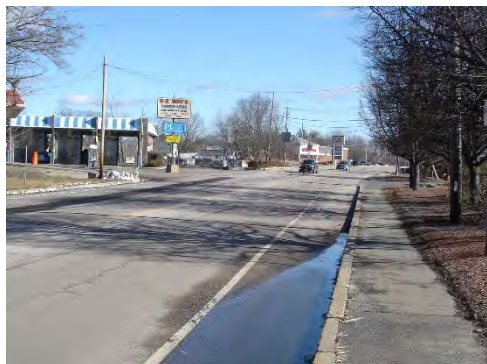
Another issue identified at this site is the access control at the two driveways located across from each other on Medway Road (Route 109) a few hundred feet east (south) of the intersection: the E-Z Way Car Wash driveway on the north side of the road and the Five Guys driveway on the south side, shown in **Figure 3** and **Image 2**. This roadway segment experienced 22 crashes in the three-year period specifically related to access of those driveways, eight resulting in injuries. Of those 22 crashes, at least 16 involved vehicles attempting left turns into or out of those driveways or attempting to cross Medway Road (Route 109) from one driveway to the other. Nine of them in particular involved angle crashes of eastbound vehicles attempting to turn left into the car wash driveway and colliding with westbound vehicles, and at least four of those crashes were courtesy crashes. (The term “courtesy crash” is used to describe a crash that occurs subsequent to a non-involved mainline driver giving the right-of-way, contrary to the rules of the road, to another driver. In all of the courtesy crashes at this location, a driver in the westbound left lane stopped to allow an eastbound left-turning vehicle through, and the turning vehicle then collided with a vehicle in the westbound right lane.)

Image 2: E-Z Way Carwash Driveway (left) and Five Guys Driveway (right) on Medway Road (Route 109)

Another contributing factor to the high crash rate at this location may be that the car wash driveway is 160 feet wide, which could be causing driver confusion in the delineation of movements.

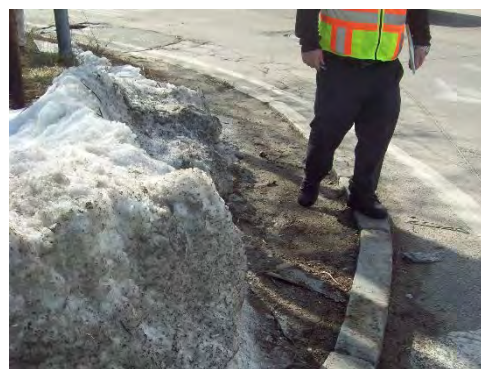
During the field visit, it was noted that there are tire tracks in the mud outside the curb on the southeast corner of the intersection (**Image 3**), which indicates that larger vehicles may be having difficulty making the right turn from northbound Medway Road (Route 109) to eastbound East Main Street (Route 16). If the curb radius is insufficient at that corner, not only would some trucks climb the curb to make the turn, but others may be breaching the adjacent lane by steering wide on the turn. In fact, one crash at this site occurred when a truck attempted a wide right turn and collided with a vehicle in the adjacent lane. This issue could be mitigated by increasing the curb radius on this corner to facilitate truck turning movements.

Image 3: Tire Tracks on Southeast Corner of Intersection

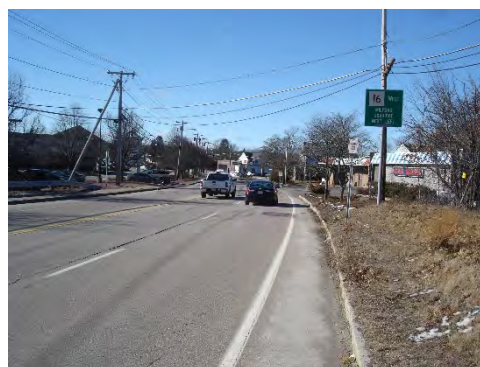
Image 4: Shoulder on North (East) Side of Medway Road (Route 109)

Shoulders could be widened to 5 feet on the east leg of East Main Street (Route 16), and they also could be widened on the north (east) side of Medway Road (Route 109) for a distance of at least 600 feet from the intersection. These enhancements would provide more roadway width for bicycles to use, further separating bicycles from motor vehicle traffic.

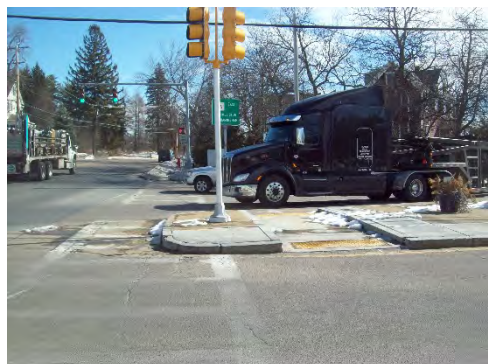
Image 5: Median on South Leg of Intersection

The existing median on the south leg of the intersection encroaches upon the crosswalk, and ramps on the median do not align with the crosswalk, as shown in **Image 5**. It appears that the median ramp was designed with the intention of the median providing pedestrian refuge. However, there is no pedestrian pushbutton located on that median, which makes pedestrian refuge problematic. Further, the existing phase split and pedestrian clearance time for the crossing of that leg appear to be insufficient for a pedestrian to complete the full crossing without the need for pedestrian refuge.

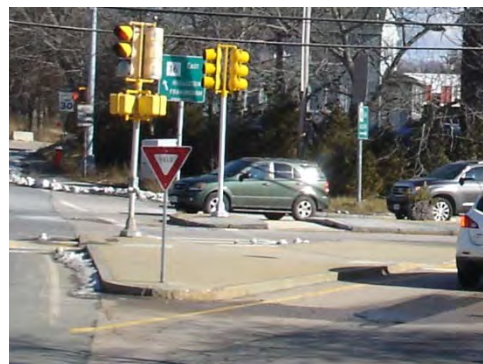
In addition to signing and pavement marking enhancements discussed previously as part of potential countermeasures for identified issues, another issue was identified that is specific to signing and pavement markings. Eastbound right-turning traffic has a yield condition at the end of the turn bay where traffic merges with southbound traffic. At present, there is a yield sign on either side of the turn bay

Image 6: Yield Sign for Channelized Right-Turn Lane

The position of both Yield signs for the eastbound channelized right turn could be adjusted so they are located closer to the yield point, emphasizing the yield point location and improving compliance, and the small sign could be replaced with a larger sign panel and mounted at the proper height. Due to the curve of the turn bay, the sign on the right might be more difficult to see on the approach if it is moved downstream. However, the presence of the sign on the left plus an existing advanced warning “Yield Ahead” sign should be sufficient. Placement of these signs would need to take into account placement of any signs related to the pedestrian crossing, as discussed previously. Installation of a yield line (triangles) could be considered, in coordination with those pedestrian crossing improvements.

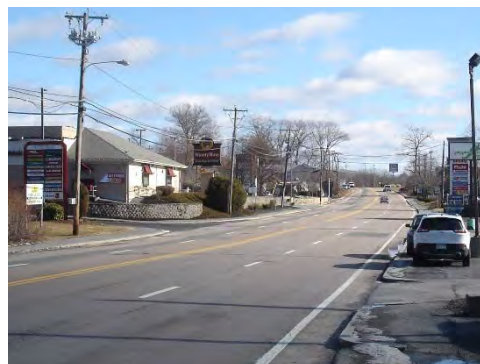
At this location, the patterns of angle crashes involving these driveways suggest that installing traffic signals could reduce crash frequency. These driveway intersections could be evaluated for whether they meet the traffic signal warrants specified in the *Manual on Uniform Traffic Control Devices (MUTCD)*, and then potential installation of traffic signals at one or both of these intersections could be assessed. As these driveways are located approximately 300 feet apart, the assessment should consider the operational effects at both driveways of applying signalization to one, the other, or both locations. If both driveways were to be signalized, the signals could either operate off a single traffic signal controller or be coordinated with each other. A traffic signal advanced warning sign could be installed for westbound traffic due to a hill and horizontal curve on the approach limiting visibility, especially for a signal at the east driveway location.

Image 7: Looking East on Route 16 with Quarry Square West Driveway on Left

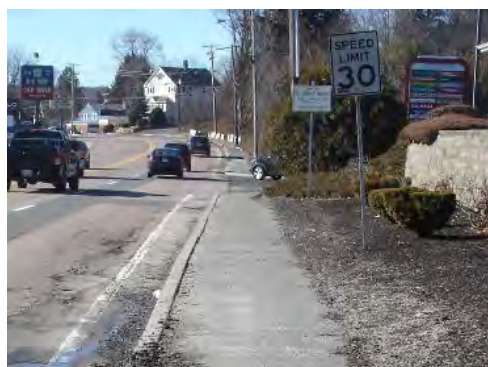
Image 8: Vegetation Obstructing Sight Lines on Northeast Corner of Quarry Square West Driveway Intersection (Looking West Towards Driveway)

Another issue observed for southbound vehicles exiting the west driveway is that the sight line to the left is obstructed by vegetation growing on the northeast corner, as shown in **Image 8**. Insufficient sight lines could contribute to angle crashes between vehicles exiting that driveway and westbound traffic.

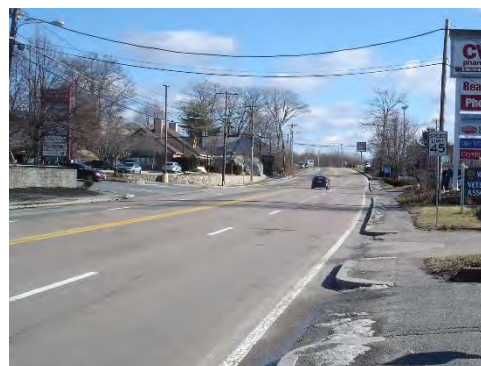
The crash history indicates that excessive speed was a contributing factor in at least one of the crashes at this site. It was observed that vehicle speeds on East Main Street (Route 16) may be excessive due to the presence and location of speed limit changes for both directions in the vicinity of this site. The eastbound speed limit increases from 30 MPH to 45 MPH between the Quarry Square driveways (**Image 9**), and the westbound speed limit decreases from 45 MPH to 30 MPH where the roadway cross-section changes from two lanes to four, approximately 350 feet in advance of the east Quarry

Image 9: Looking East on Route 16 with Quarry Square East Driveway on Left and Eastbound 45 MPH Speed Limit Sign on Right

Square driveway. Eastbound vehicles may begin to increase their speed hundreds of feet in advance of the sign, resulting in higher speeds across this entire roadway section. And although westbound traffic has undergone a speed limit reduction immediately before entering this section, many vehicles may still be making the speed adjustment as they pass both Quarry Square driveways and traveling well above the 30 MPH speed limit.

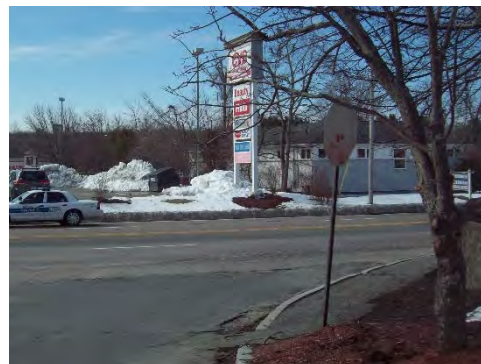
sign and either pulling too far forward before coming to a stop or failing to come to a complete stop at all. At the east driveway, the stop sign is faded and misaligned, as shown in **Image 10**.

Image 10: Faded and Misaligned Stop Sign at Quarry Square East Driveway

The angle of the east driveway's misaligned stop sign post could be fixed and the sign panel replaced, which could improve compliance with the stop condition.

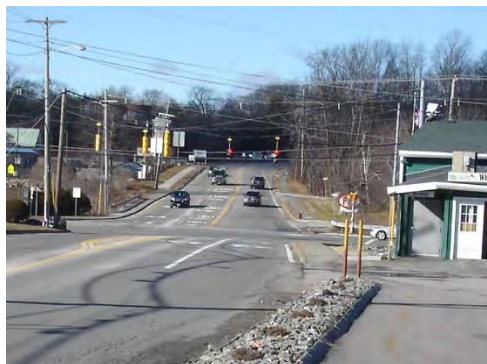
At this intersection, the Beaver Street northbound approach consists of two lanes, both of which accommodate through movements. However, the receiving bay on the Fortune Boulevard north leg has just a single lane, which measures 24 feet wide at its opening but narrows to under 20 feet within the first 120 feet of the departure lane (**Figure 5** and **Image 11**). Under this configuration, through-moving vehicles are forced to merge over a short distance, which may lead to sideswipe and rear-end crashes, though none of those types of crashes are apparent in the three-year crash history reviewed.

Image 11: Northbound Approach of Beaver Street at Intersection with East Main Street (Route 109)

A potential short-term countermeasure would be to install advanced warning signage for the lane reduction on the northbound departure, as currently there is no advanced warning information provided. This improvement would better alert drivers to the impending merge condition.

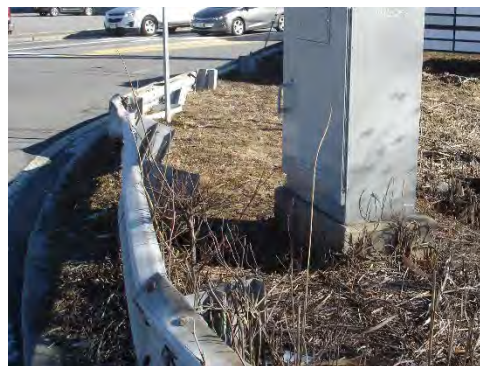
Image 12: Guardrail Damage on the Southwest Corner of the Intersection with Beaver Street and Fortune Boulevard

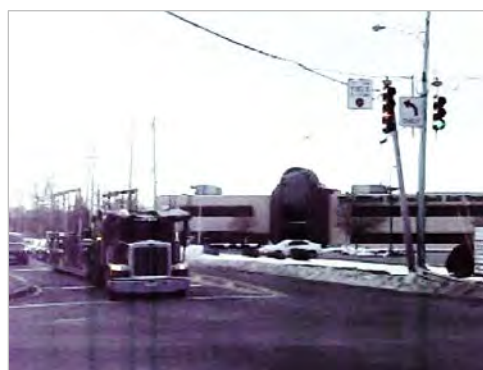
Two features were noted at the intersection indicating that trucks have difficulty making right turns on the eastbound East Main Street (Route 16) and northbound Beaver Street approaches to the intersection. The guardrail on the southwest corner has severe damage (**Image 12**), likely due to trucks colliding with it while making the right turn from eastbound to southbound. Similarly, trucks turning right from northbound to eastbound were observed to make wide turns, fully breaching the left lane of the northbound approach in order to make the turn (**Image 13**), which may lead to sideswipe crashes and other types of crashes. The three-year

Image 13: Northbound Truck on Beaver Street Turning Right from Left Lane

crash history included one crash involving a northbound right-turning truck that may be indicative of this issue.

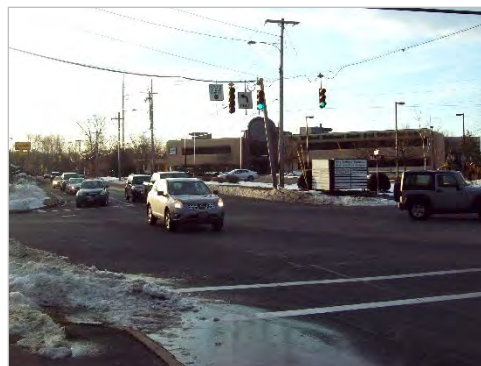
During the audit, ponding of water was observed on the east side of Fortune Boulevard at the curb return for this intersection (**Image 14**). The ponding was observed to cause northbound through traffic to shy to the left, complicating the merge maneuver previously discussed and increasing the potential for sideswipe crashes. Nevertheless, the crash data for the study period did not indicate this issue was a contributing factor in any of the crashes.

Image 14: Ponding on Fortune Boulevard at Intersection

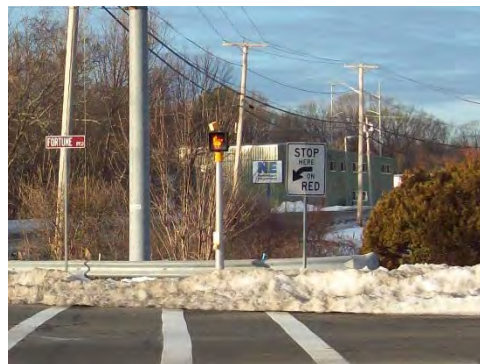
Some of the pedestrian signal equipment appeared to be in disrepair or not up to current standards. Multiple pedestrian signal heads were observed to be in poor condition, and they are not countdown-style (**Image 15**). Also, the audible function of the APS-style pedestrian pushbuttons appeared to be nonfunctional on at least one corner.

It was observed in the field that the Stop Here On Red sign for the southbound Fortune Boulevard approach to the intersection is misaligned, aimed more towards westbound traffic than southbound, as shown in **Image 15**.

Image 15: Pedestrian Signal Head with Some LEDs Nonfunctional and Misaligned Stop Here On Red Sign on Northwest Corner of Intersection

Potential signal system improvements include upgrading the existing pedestrian signal heads to countdown-style to provide pedestrians valuable information on how much time they have to cross, and evaluating the pushbuttons for repair or replacement. These enhancements would improve pedestrian safety and mobility.

To make the Stop Here On Red sign on the southbound approach more visible for the intended traffic stream, the angle of the sign post could be fixed, which could improve compliance for stopping at the proper location.

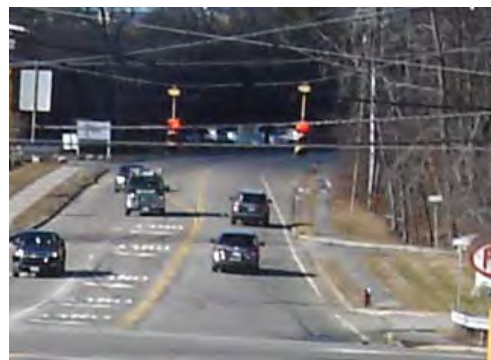
The view of the vehicular signal heads for the northbound approach appears to be partially obscured by utility lines crossing the north leg of the intersection in front of the signal heads (**Image 16**). This increases the potential for angle crashes from red-light running and rear-end crashes due to drivers not seeing the signal phase change.

Image 16: Utility Lines Obstructing View of Northbound Signal Heads
