Structural Evaluation

Milford, MA Live Fire Training Structure ("Burn Building")

EL&M No.: 22049

November 30, 2022

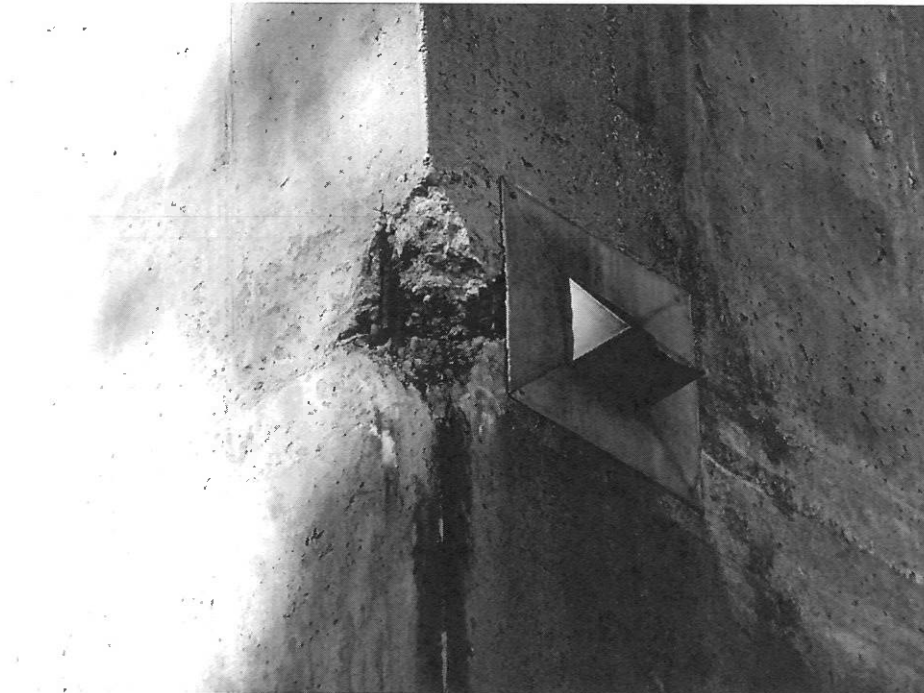
| Item | Observations and Recommended Actions |
|--|--|
| Concrete Walls (Items A, C, D, F, G, 4, 7, and 11 in Appendix 1) | <p><u>Observations:</u> Minor <i>cracks</i> and <i>crazing</i>, likely due to a combination of concrete shrinkage during the initial curing, thermal expansion and contraction during live fire training, and exposure to weather. The cracks and crazing do not appear to be a structural concern at this time but could widen with time due to exposure.</p> <p>There are a few areas of <i>efflorescence</i> at the A elevation that appear to occur at cold joints, indicating that moisture is passing through and/or gathering at the surface of the joints. These areas do not appear to be a structural concern at this time.</p> <p>There are moderate to severe <i>spalls</i> with exposed, corroded reinforcing at the exterior AB and BC corners of the structure, as well as at the exterior B elevation.</p> <p>There are moderate <i>cracks and spalls</i> with exposed reinforcing and <i>efflorescence</i> at the door lintel between Rooms 200 and 201.</p> <p>It appears that the concrete was not properly consolidated when poured, leaving some voids in the exposed concrete walls. It also appears that some reinforcing bars did not have proper concrete cover when the walls were poured, causing the bars to become exposed within shallow spalls.</p> <p><u>Recommended Actions:</u> Patch all interior and exterior wall spalls and delaminations, including at the door lintel between Rooms 200 and 201. Remove loose concrete and remove corrosion from any exposed reinforcing bars. Remove concrete around exposed bars by a minimum of 1". Replace any reinforcing bars that have lost more than 15% of their cross-sectional area. Patch spalls with a high-strength, high-bond-strength, non-shrink patch material manufactured by Sika Corporation, Euclid Chemical Company, or other equivalent manufacturer that is suitable for exterior vertical applications. Follow manufacturer's instructions for preparing surface and mixing, placing, and curing patch material.</p> |

Spall at AB corner of building with exposed reinforcing (second floor).

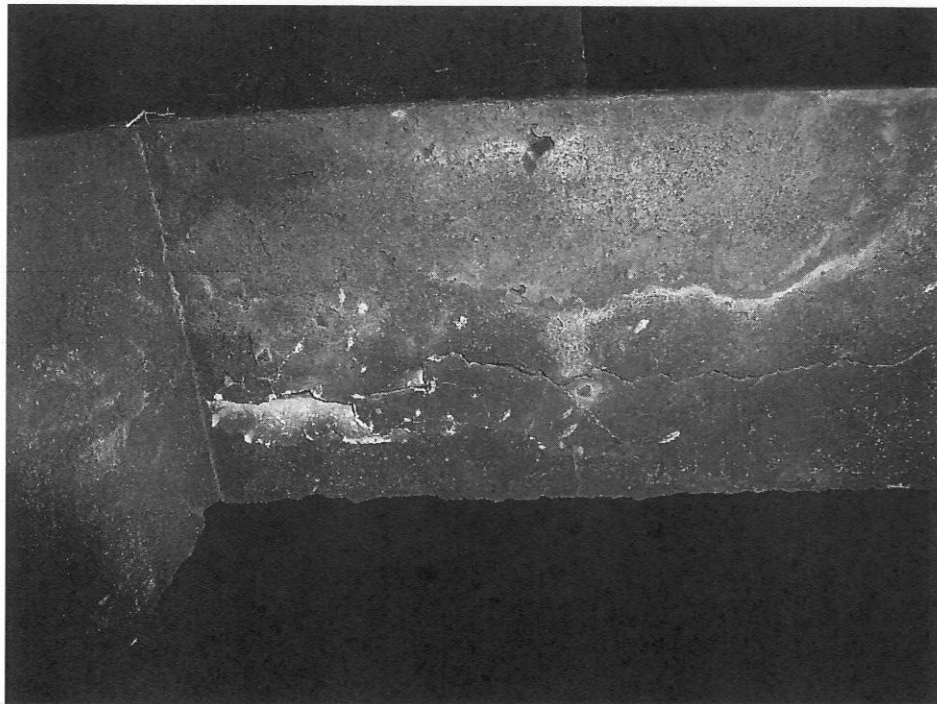
Cracks and exposed reinforcing in lintel over doorway between Rooms 200 and 201.

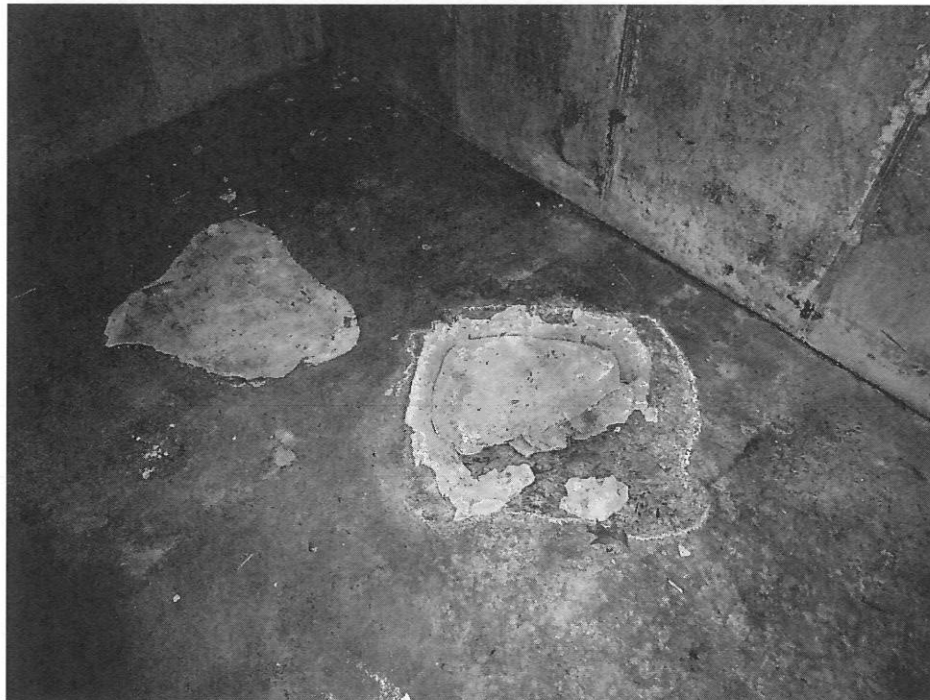
| Item | Observations and Recommended Actions |
|--|---|
| Concrete Floor and Roof Slabs (Items 1, 3, 4, 5, 8, 9, and 14 in Appendix 1) | <p><u>Observations:</u> Minor <i>cracks</i>, <i>spalls</i>, and <i>delaminations</i> in the top surfaces of the slab-on-grade, and the top and bottom surfaces of the second and third floor slabs. This damage was likely caused by concrete shrinkage during the initial curing (cracks only) and high temperatures and flame impingement on the exposed floor slabs (cracks, spalls, and delaminations). The spalls and delaminations are shallow and do not appear to be as deep as the reinforcing layers. Some of the delaminations appear to be located at areas of previously-patched concrete. The spalls and delaminations do not significantly affect the capacity of the slabs and do not appear to allow moisture to penetrate into the concrete surface. However, a few of the spalls are deep enough to require repair to remove areas where water collects and to provide a smooth surface, should fire brick be placed on the floors in the future.</p> <p>The cracks are typically narrow (less than 1/32") and do not appear to allow water to reach the reinforcing.</p> <p>In Room 300, there are severe <i>spalls</i>, <i>cracks</i> and <i>delaminations</i> surrounding the roof hatch opening.</p> <p>It appears that the concrete was not properly consolidated when poured, leaving some voids in the exposed concrete slabs. It also appears that some reinforcing bars did not have proper concrete cover when the slabs were poured, causing the bars to become exposed within shallow spalls.</p> <p><u>Recommended Actions:</u> Patch spalls in the tops of the slabs in Rooms 100 and 101, where fire brick might be placed on the floors in the future and where the spalls are rough on the hands and knees of personnel during training. Where spalls have been previously patched and the patch has worked loose, remove the old patch prior to providing a new patch.</p> <p>Patch spalls at the underside of the roof slab (ceiling of Room 300).</p> <p>For all spall/delamination repairs, remove loose concrete and remove corrosion from any exposed reinforcing bars. Remove concrete around exposed bars</p> |

Spalled patches at top of slab-on-grade in Room 101.

| Item | Observations and Recommended Actions |
|---|--|
| Concrete Floor and Roof Slabs (Items 1, 3, 4, 5, 8, 9, and 14 in Appendix 1) (Continued) | <p>by a minimum of 1". Replace any reinforcing bars that have lost more than 15% of their cross-sectional area. Patch spalls with a high-strength, high-bond-strength, non-shrink patch material manufactured by Sika Corporation, Euclid Chemical Company, or other equivalent manufacturer that is suitable for exterior horizontal (at tops of slabs) and overhead (at bottoms of slabs) applications. Follow manufacturer's instructions for preparing surface and mixing, placing, and curing patch material.</p> <p>Provide fire brick on the floor for the extents of Rooms 100 and 101, and burn only on burn racks that do not allow burning fuel, coals, ash, or embers to fall to / rest upon the floor in order to reduce the risk of new damage and patches failing if burning is going to continue in these rooms.</p> |

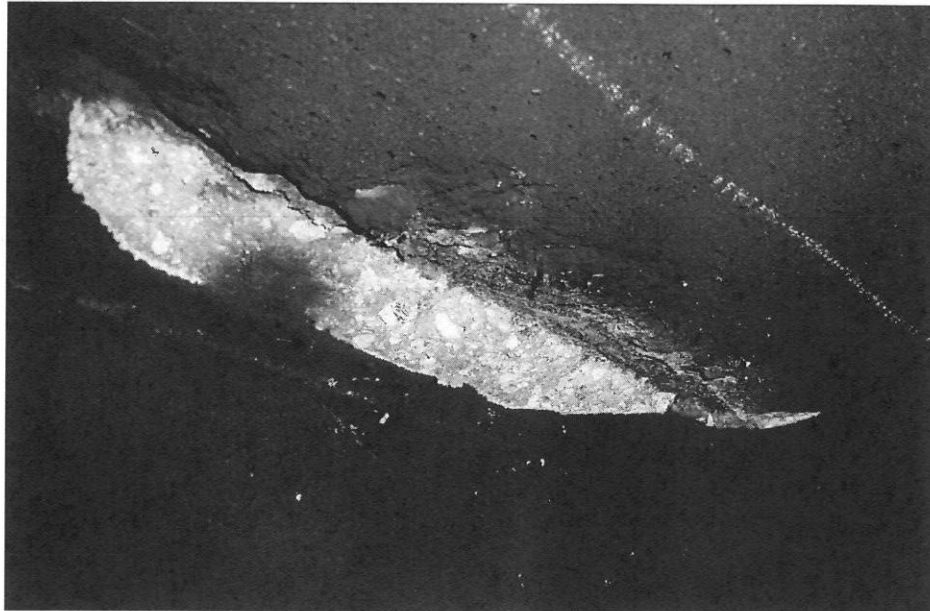
Spall with exposed, corroded rebar at the ceiling of Room 300.

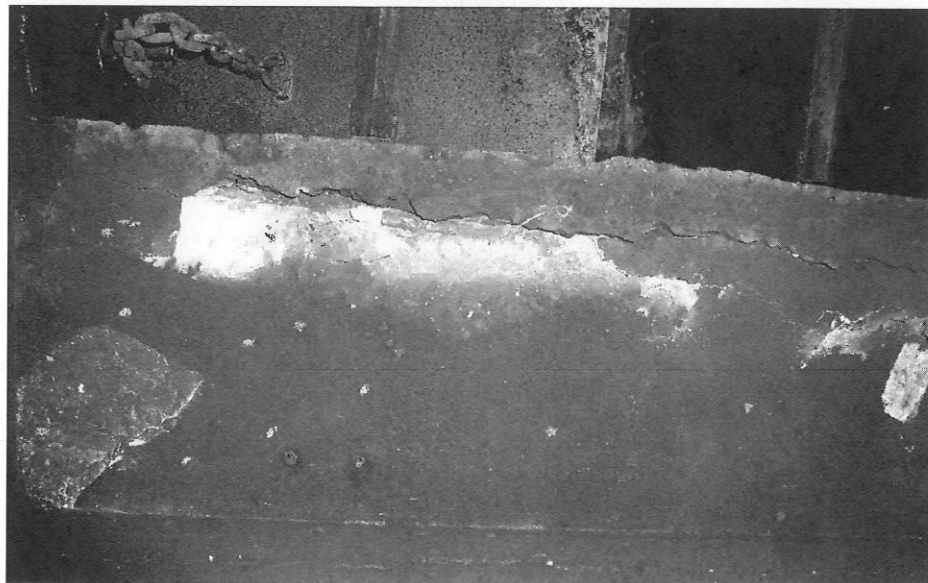
Spall with exposed, corroded rebar and delaminated concrete at the ceiling of Room 300 adjacent to the roof opening.

- Remove all loose concrete from the beams and underside of slab surrounding the roof chopout opening at the third floor ceiling.
- Patch all spalls as described in the body of the report.

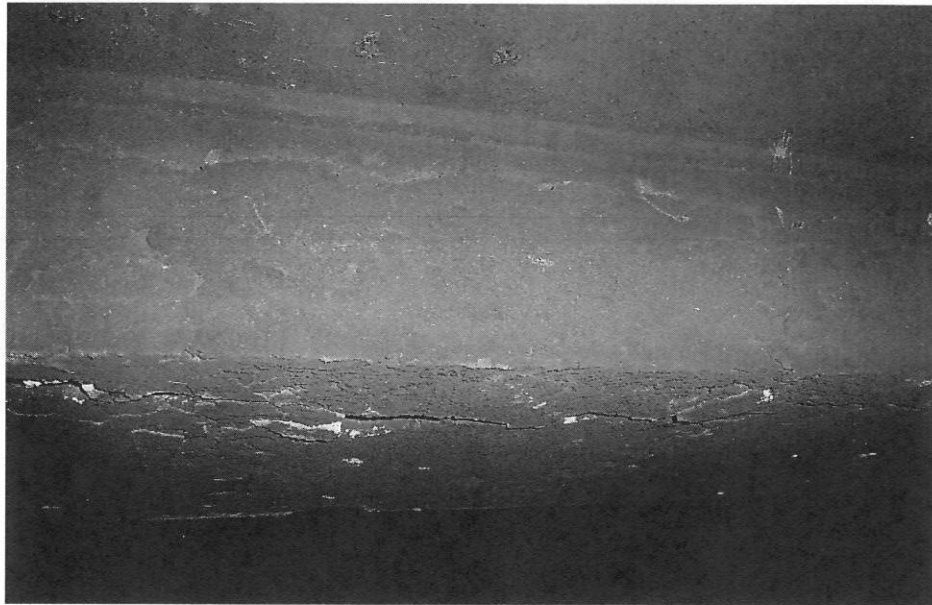
| Item | Observations and Recommended Actions |
|--|--|
| Concrete Beams (Items 14 and 15 in Appendix 1) | <p><u>Observations:</u> There are minor <i>cracks</i> and <i>efflorescence</i>, on the beams below the second floor slab, likely due to a combination of concrete shrinkage during the initial curing, thermal expansion and contraction during live fire training, and exposure to weather. The cracks do not appear to be a structural concern at this time but could gradually widen with time due to exposure.</p> <p>There are moderate to severe <i>cracks</i>, <i>spalls</i>, and <i>delaminations</i> on the beams below the sloped concrete roof and below the high roof (ceiling of Room 300), adjacent to the roof chopout opening.</p> <p><u>Recommended Actions:</u> Epoxy inject cracks that are wider than 1/16" and narrower than 1/8" with Sikadur 52 or an equivalent product.</p> <p>For beams with spalls, delaminations, and cracks wider than 1/8", remove loose concrete and remove corrosion from any exposed reinforcing bars. Remove concrete around exposed bars by a minimum of 1". Replace any reinforcing bars that have lost more than 15% of their cross-sectional area. Patch spalls with a high-strength, high-bond-strength, non-shrink patch material manufactured by Sika Corporation, Euclid Chemical Company, or other equivalent manufacturer that is suitable for exterior overhead and vertical applications, or form-and-pour patch material, to patch and, if necessary, re-build beam soffits. Follow manufacturer's instructions for preparing surface and mixing, placing, and curing patch material. If significant volumes of concrete are delaminated/spalled, it is possible that the beam(s) will have to be demolished and re-poured with new cast-in-place concrete instead of patching.</p> |

Severely delaminated and cracked beam at underside of high roof slab.

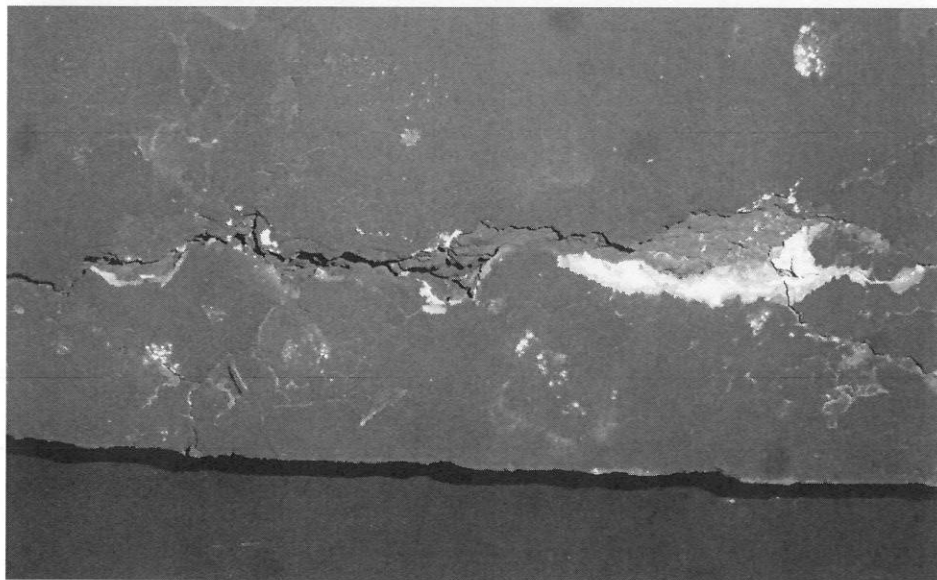
Severely delaminated and cracked beam at underside of high roof slab.

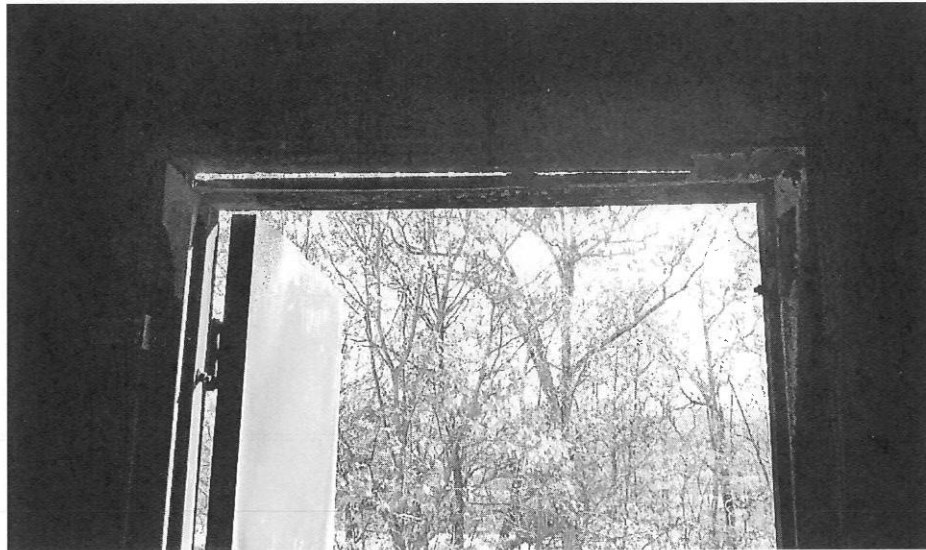
| Item | Observations and Recommended Actions |
|---|---|
| Exterior and Interior Doors & Frames (Items I and 13 in Appendix 1) | <p><u>Observations:</u> The two exterior doors and frames to the second and third floor balconies are severely corroded.</p> <p>The door latch into Room 101 from the exterior sticks and is difficult to operate.</p> <p><u>Recommended Actions:</u> Remove the corroded doors and frames and replace with new doors in Rooms 200 and 300.</p> <p>Replace the sticking door handle at the exterior door into Room 101.</p> |

Severely corroded door frame in Room 300.

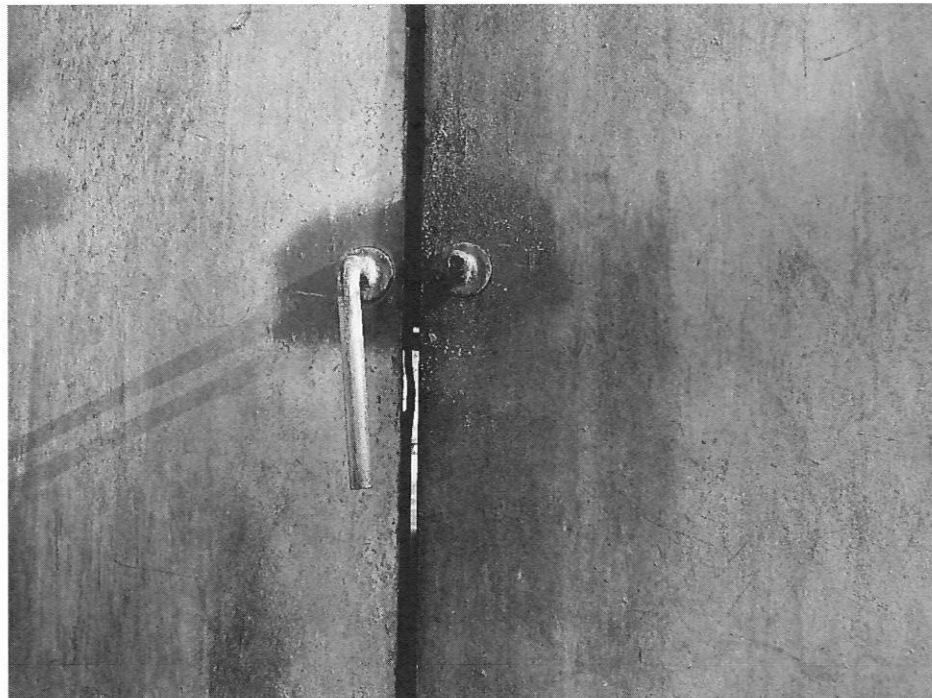
| Item | Observations and Recommended Actions |
|---|--|
| Windows (Item H in Appendix 1) | <p><u>Observations:</u> There is minor corrosion on all of the shutter plates.</p> <p>The latch handle on the right leaf (from the exterior) of the shutter in Room 100 is broken.</p> <p><u>Recommended Actions:</u> Replace the broken handle at the shutter in Room 100. No repair is required for the minor corrosion on the shutter plates.</p> |

Broken shutter handle.

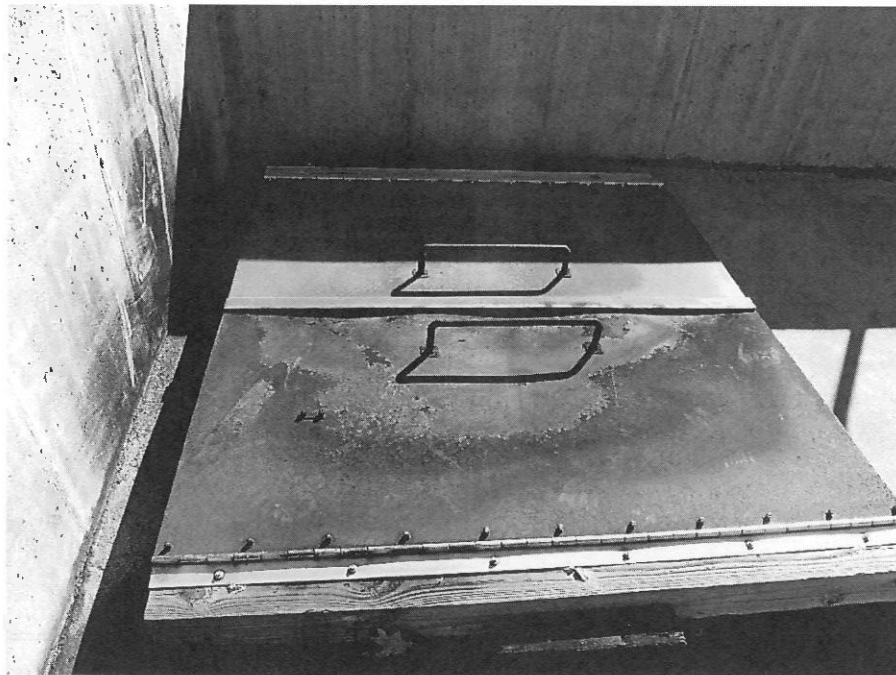
| Item | Observations and Recommended Actions |
|---|---|
| Roof Access Hatches | <p><u>Observations:</u> The steel cover plates and frames at the roof access hatches are slightly warped and moderately corroded.</p> <p><u>Recommended Actions:</u> If desired, remove corrosion and paint steel items with two coats of a rust-inhibiting, exterior-quality paint. Otherwise, no additional action is recommended at this time.</p> |

Warped and corroded roof chopout cover plates.

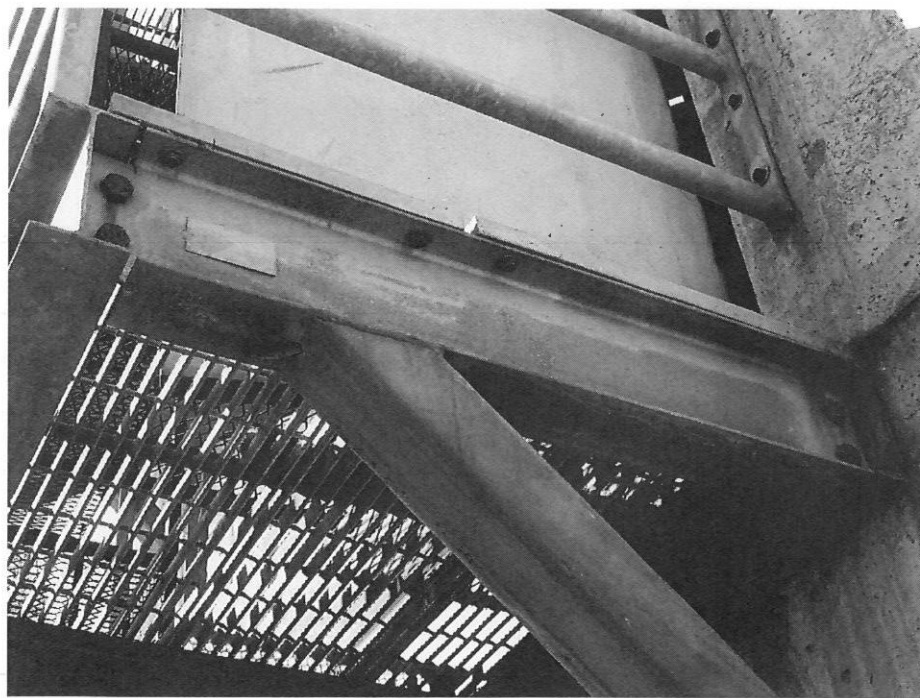
| Item | Observations and Recommended Actions |
|--|---|
| Exterior Steel Balconies (Items K and L in Appendix 1) | <p><u>Observations:</u> There is minor corrosion on the exterior steel balconies, railings, and connections. The galvanizing vent holes at the steel tube kickers have not been plugged, which could allow water to get into the tubes and freeze during winter months, which could cause the steel to expand and crack. The holes allow nesting insects and a yellow jacket nest was visible.</p> <p><u>Recommended Actions:</u> If desired, remove all corrosion and touch up galvanizing with two coats of galvanizing repair paint.</p> <p>Plug all vent holes by either (A) hammering in a zinc galvanizing vent hole plug by Bruce Reichelt Enterprises, grind it smooth, and touch up with galvanizing repair paint or (B) plug welding the vent holes, grinding the welds smooth, and touching up with galvanizing repair paint. Drill a 1/2" diameter weep hole at the bottom of each tube kicker, 1" above the diagonal from the wall connection, to allow water to drain. Touch up the hole with galvanizing repair paint.</p> |

Minor corrosion on balcony steel framing, railings, and connections.

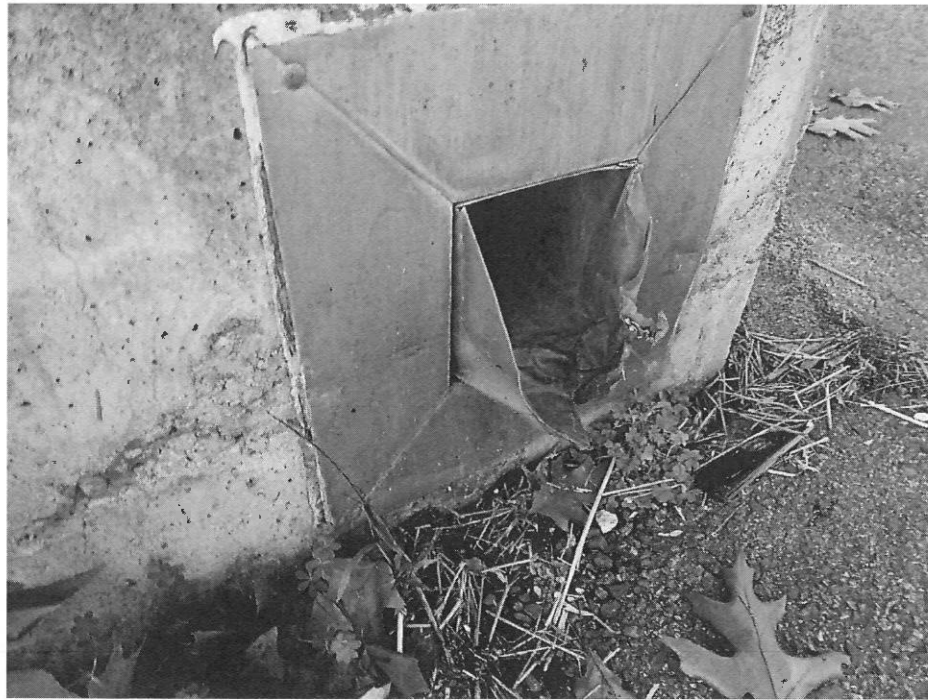
| Item | Observations and Recommended Actions |
|---|---|
| Scuppers (Item B in Appendix 1) | <p><u>Observations:</u> The sheet steel at the majority of the scupper openings is severely damaged.</p> <p><u>Recommended Actions:</u> Remove the damaged sheet steel, especially at the ground floor level so it doesn't snag gear or hoses. If desired, replace the sheet steel with a thicker gauge steel or steel plate to better withstand impact and debris.</p> |

Damaged sheet steel at ground floor scupper opening.

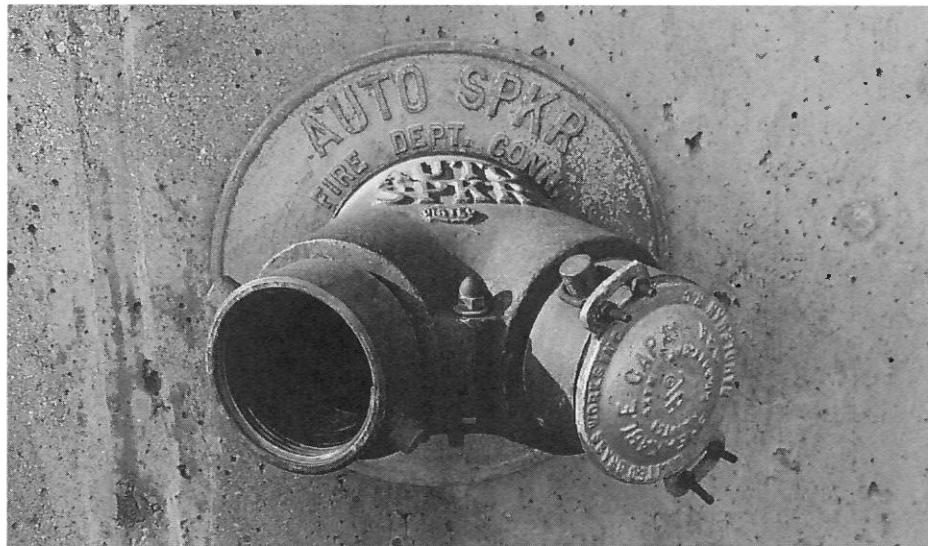
| Item | Observations and Recommended Actions |
|--|--|
| F.D.C. and sprinkler pipes (Items J and 6 in Appendix 1) | <p><u>Observations:</u> The F.D.C. is missing the left valve cap.</p> <p>The sprinkler pipes and hangers throughout the building are broken and/or missing.</p> <p><u>Recommended Actions:</u> Replace the missing F.D.C. valve cap. If desired, replace the broken/missing sprinkler pipes and hangers.</p> |

Missing valve cap at F.D.C.

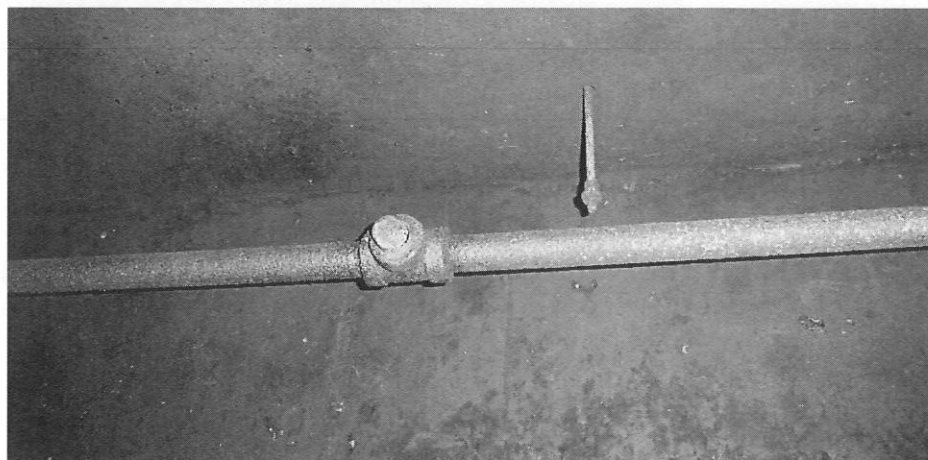
Broken sprinkler pipes/hangers.
