ROAD SAFETY AUDIT

East Main Street (Route 16) at Medway Road (Route 109),
East Main Street (Route 16) at Quarry Square Driveways,
East Main Street (Route 16) at Beaver Street/
Fortune Boulevard

Town of Milford

May 18, 2017

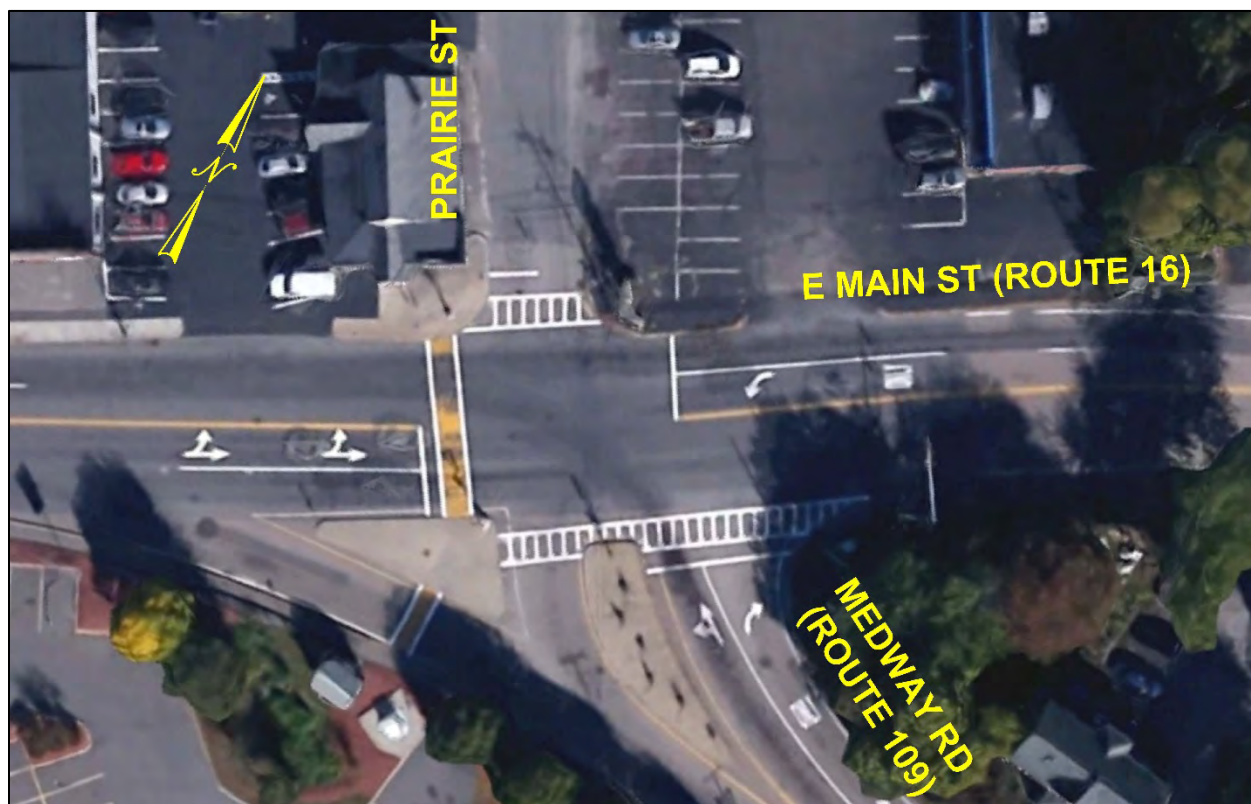
Figure 2: Intersection of Medway Road (Route 109)/Prairie Street at East Main Street (Route 16)

To the east of the intersection, East Main Street (Route 16) consists of two travel lanes in each direction. On the approach to the intersection, the left westbound lane becomes an exclusive left-turn lane, approximately 75 feet in advance of the stop line, as shown in **Figure 2** and **Image 1**. This lane-drop configuration is often called a left-turn lane trap. The transition from a general-purpose travel lane to an exclusive turn lane at this location is abrupt with no advanced warning. This configuration creates a situation where vehicles attempt to make last-moment lane changes, particularly from the left lane to the right lane in order to continue going straight. As observed in the field, vehicles sometimes make a through movement from the left lane, probably having not noticed the change in lane configuration in time to merge before the intersection, which results in a merge situation within or just beyond the intersection that is unexpected for drivers in the other lane. Two sideswipe crashes identified in the crash history analysis are likely attributed to this issue, where a vehicle in the left lane attempted a sudden lane change to the right on the approach to or within the intersection, striking a vehicle to its right.

Advanced warning signage and associated pavement markings could be installed on the intersection's westbound approach to warn of the lane drop and/or indicate that the left travel lane becomes an exclusive left-turn lane. Signage could include a "Left Lane Must Turn Left" sign (R3-7L) or a graphical advance intersection lane control sign (R3-8). Supplementally, a left-turn only sign (R3-5L) could be posted on the signal mast arm over the projection of the left lane to emphasize the lane use designation. Pavement markings could include a wide dotted white lane line in advance of the turning lane bay (MUTCD Figure 3B-11A).

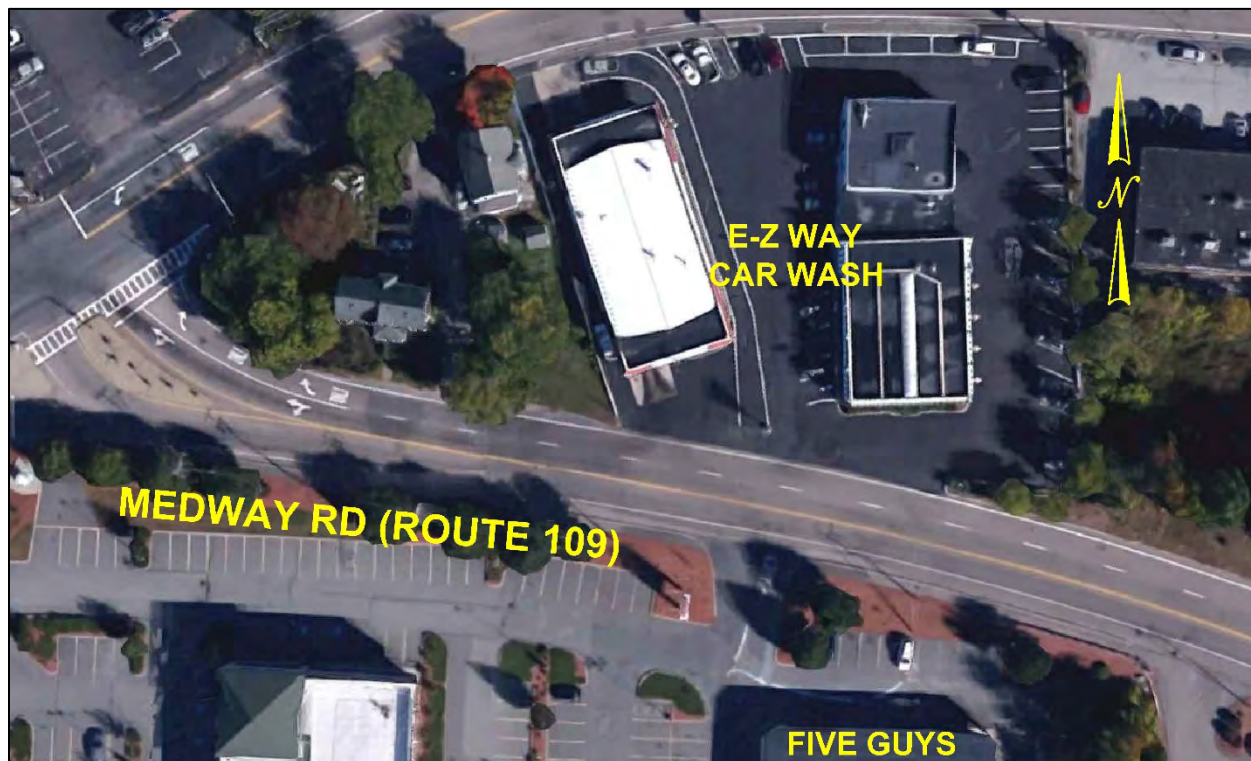
Figure 3: Driveways on Medway Road (Route 109) Near East Main Street (Route 16)

Another issue identified at this site is the access control at the two driveways located across from each other on Medway Road (Route 109) a few hundred feet east (south) of the intersection: the E-Z Way Car Wash driveway on the north side of the road and the Five Guys driveway on the south side, shown in **Figure 3** and **Image 2**. This roadway segment experienced 22 crashes in the three-year period specifically related to access of those driveways, eight resulting in injuries. Of those 22 crashes, at least 16 involved vehicles attempting left turns into or out of those driveways or attempting to cross Medway Road (Route 109) from one driveway to the other. Nine of them in particular involved angle crashes of eastbound vehicles attempting to turn left into the car wash driveway and colliding with westbound vehicles, and at least four of those crashes were courtesy crashes. (The term “courtesy crash” is used to describe a crash that occurs subsequent to a non-involved mainline driver giving the right-of-way, contrary to the rules of the road, to another driver. In all of the courtesy crashes at this location, a driver in the westbound left lane stopped to allow an eastbound left-turning vehicle through, and the turning vehicle then collided with a vehicle in the westbound right lane.)

Currently, there is no designated space for bicycle travel along East Main Street (Route 16) or Medway Road (Route 109), although edge lines are generally present on the east and south legs of the intersection. Shoulders on the east leg of East Main Street (Route 16) are about 2 feet wide and insufficient for bicycle use. The shoulder on the south (west) side of Medway Road (Route 109) is about 7 feet wide. The shoulder on the north (east) side of Medway Road (Route 109) has variable width, measuring from 2 to 7 feet wide, and is insufficient for bicycle use due to the narrow areas (**Figure 3** and **Image 4**).

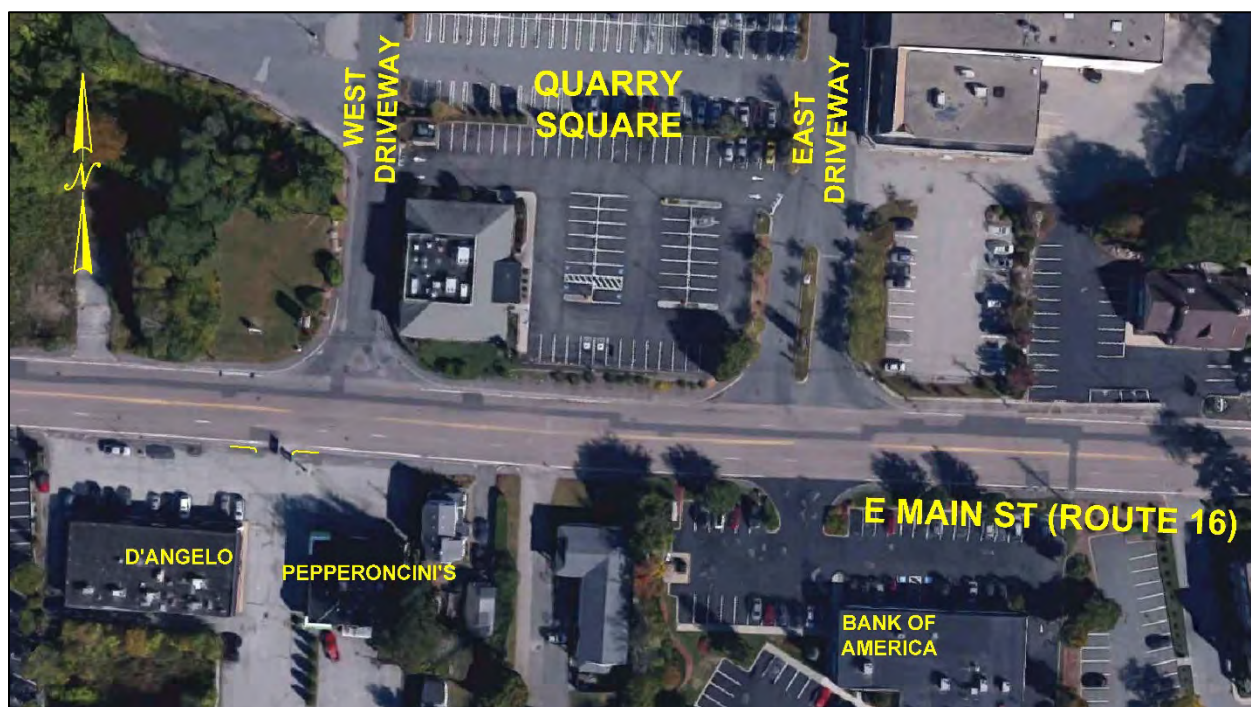
Figure 4: Quarry Square Driveways at East Main Street (Route 16)

A number of issues at this site emerged from the audit process specifically related to crash frequency and particular patterns of crashes. Many of the crashes along this roadway segment were angle crashes involving vehicles turning into or out of the two Quarry Square driveways or the opposing driveways on the south side of the road. The driveway intersections are currently unsignalized, as shown in **Figure 4** and **Image 7** through **Image 10**.

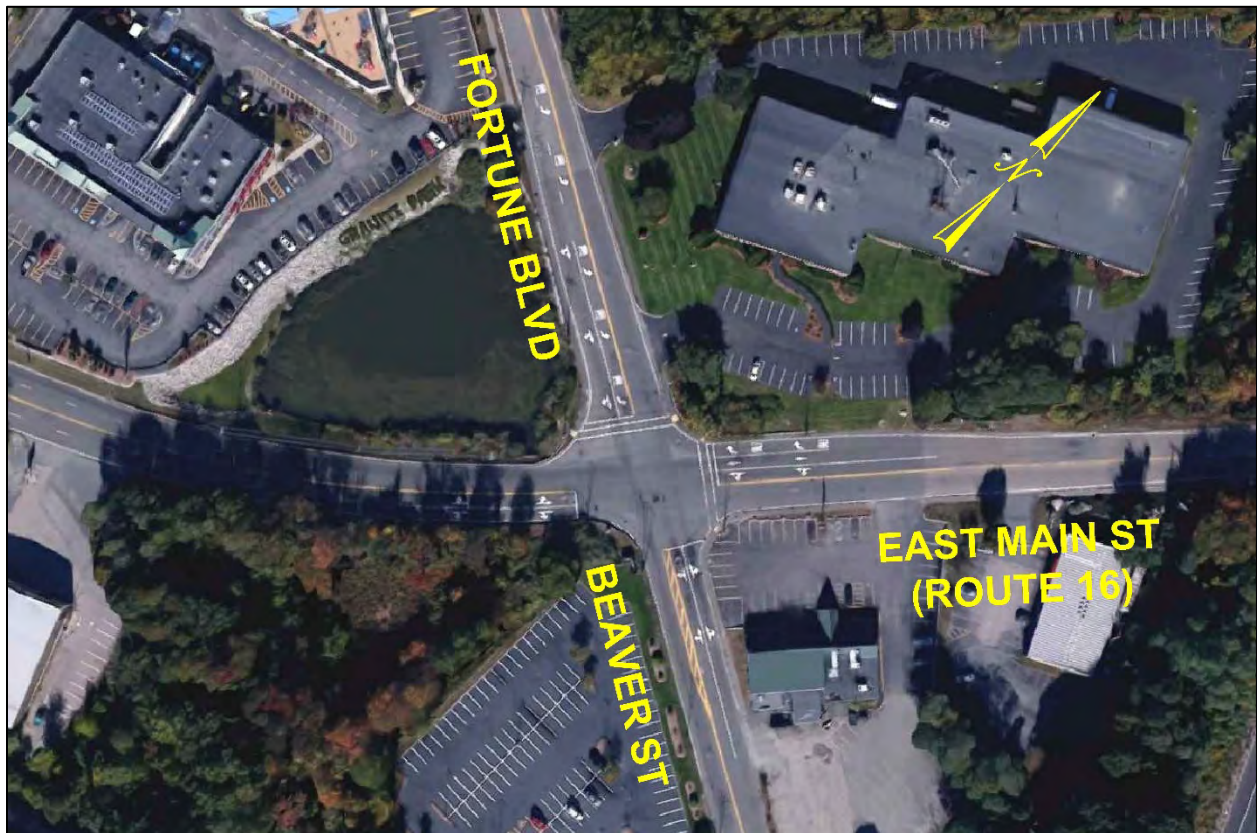
Figure 5: Intersection of Beaver Street/Fortune Boulevard at East Main Street (Route 16)

Similar to another issue discussed previously for this site, the eastbound departure has a lane reduction about 150 feet downstream of the intersection with no advanced warning signage. (Note that the aerial imagery in **Figure 5** predates the addition of lane striping on the east leg that now designates two eastbound lanes for the first 150 feet.)
