Structural Evaluation

Milford, MA Live Fire Training Structure ("Burn Building")

EL&M No.: 22049

November 30, 2022

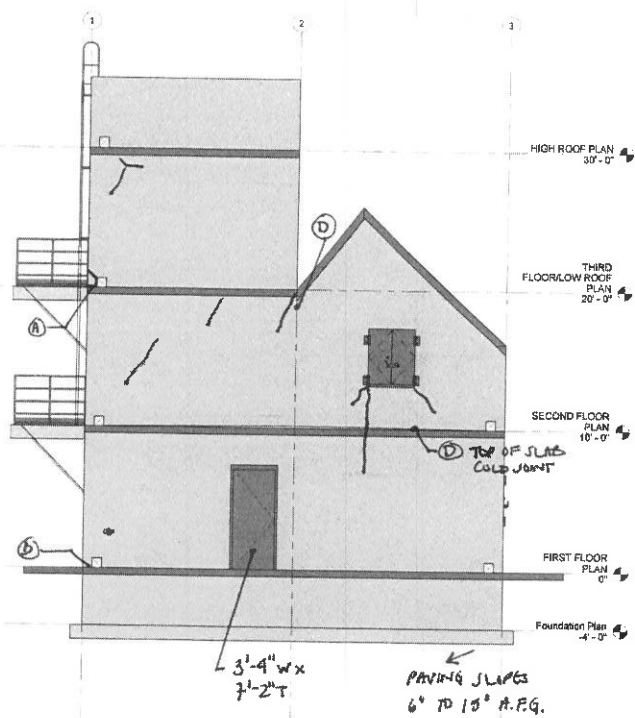
A
ELEVATION
BB103 SCALE 1/4" = 1'-0"

- (A) SPALL W/ EXPOSED REBAR
- (B) WARPED SCUPPER EXTENSIONS (ALL)
- (C) HARKLINE CRACK < 1/8"
- (D) DISCREPANCY
- (E) MISSING BOLTS
- (F) CRACKING
- (G) DEBRIS - PEELING SEALER
- (H) SHUTTER HANDLE BROKEN
- (I) DOOR STICKS -
- (J) MISSING CORNER ON FEE
- (K) MINOR COLLISION ON SINTERED & STEEL BALCONY FRAMING
- (L) OPEN GROUNDWORK - INSECTS
- (M) SPALL AT GUARD RAIL ANCHOR
